(BDIZ EDI) Implant-Study 2014/2015

# Quantitative and qualitative element-analysis of implant-surfaces by SEM and EDX

# PRELIMINARY STUDY REPORT

WIN! PEEK LOT 5886621 (R)evolution LOT 612598

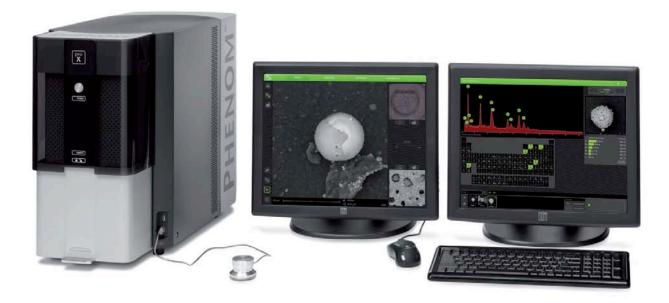
Workstation with Phenom proX Scanning Electron Microscope

The scientific workstation is a Phenom proX Scanning Electron Microscope, equipped with a high-sensitivity backscattered electron detector that allows compositional and topographical imaging modes. EDX analyses are performed with a thermoelectrically cooled Silicon Drift Detector (SDD).

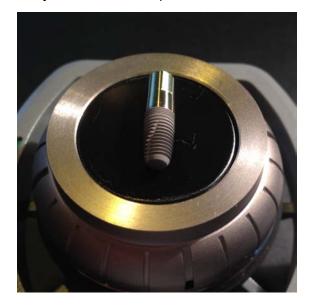
Fixed implant (example) on the sample holder

Without touching the surface, each implant will be taken out of the package with sterile forceps and will be fixed on the sample holders. After the vacuum is generated in the electron microscope imaging and EDX-analyses will be completed.

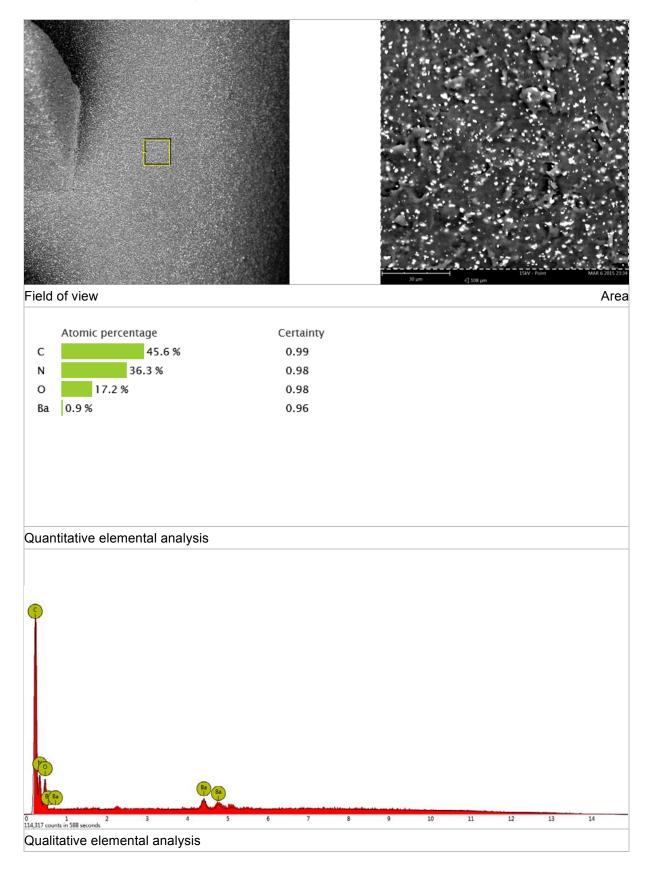
## 3.6 EDX Area Analysis

Implants GmbH for this analysis showed a high precision of the outer geometry. Significant traces of inorganic or organic residues were not found. The implant "WIN! PEEK" made of Polyetheretherketon showed a strong carbon signal due to the material used. Barium and sulfur

carbon signal due to the material used. Barium and sul

signals originate from x-ray opaque barium sulfate

(BaSo₄).

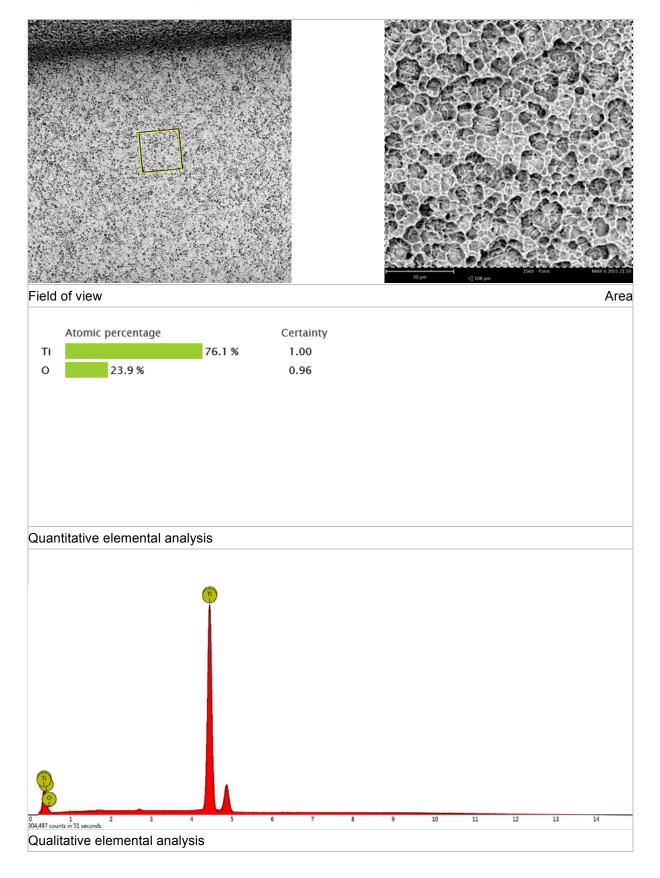
## 4.6 EDX Area Analysis

Summary/Conclusions: The implant "(R)evolution" provided by Champions-
